**Flood Control Project Maintenance
Levee Inspections**
LMA District Cover Sheet
Spring 2020 Levee Inspection Results

Reclamation District No. 2094 Walthall

Levee Inspection Report By Mile - Spring 2020

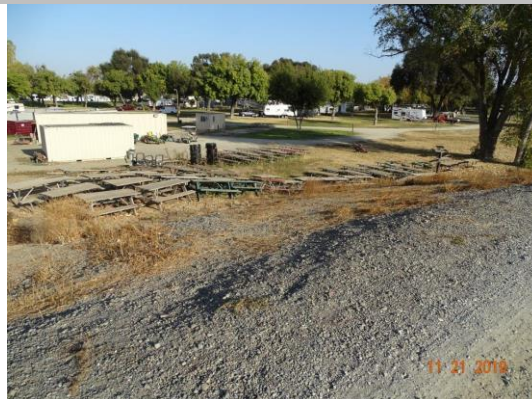
Photo 1 of 2 : SP_2020_RD2094_320_4_20200228_00001.jpg

LM Start	0.10	Rating **	A/W	Issue No.	4
LM End	0.10	Issue Type +	En	Location *	WS
Category	Earthen Levee			GPS Latitude/Longitude	
				Start	End
Item	Encroachments			37.771685 °	37.771685 °
				-121.300239 °	-121.300239 °
DWR ID	DWR_RD2094_01_s_2012_4				
Comment Code					
RA : Ramp					
Inspector Comment					
An access ramp has been built on the waterside and extends into the channel. This could potentially alter the channel capacity. This item was also noted in the USACE comments.

View of ramp on waterside slope. Fall 2019

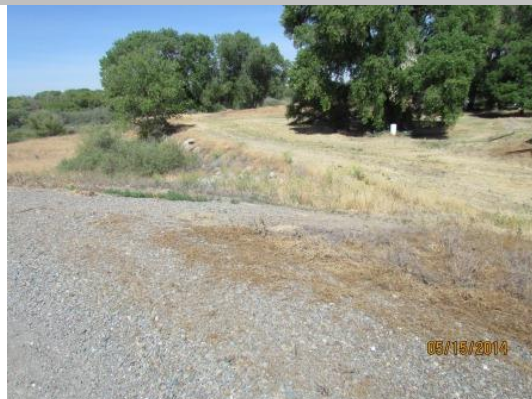
Photo 2 of 2 : SP_2020_RD2094_320_4_20200228_00002.jpg

Tire marks shown onto the ramp from levee. Raised area extends to the trees in the background in the center of the photo.

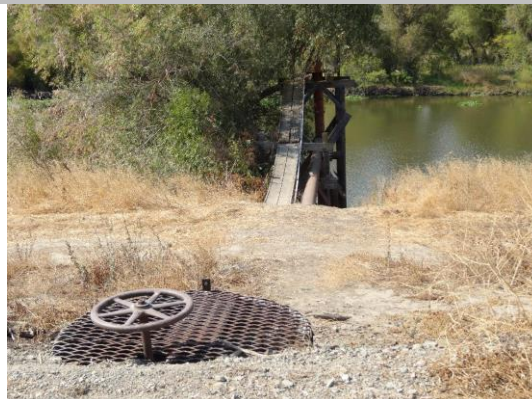
Photo 1 of 3 : UCIP_SP_2020_21464_36405.jpg

DS_ID:23086
FS_ID:21464
EP_NO: N/A
Repair Type: Non-Urgent
Crossing Status: Found
UCIP Comments: - walkway in poor condition and needs repair.- electric conduit on waterside.
FIELD_STRUCT_DESC: 14-inch concrete encased steel irrigation discharge pipe and galvanized iron (GI) electrical conduit through the levee, 10 feet below the crown. Two concrete cutoff walls. Pump mounted on a pile structure in the stream. Slide gate in a 54-inch corrugated metal pipe (CMP) riser on the waterside (WS) shoulder. Concrete distribution box and service pole at the landside (LS) toe. Installed by USACE in 1962. [Additional Reference(s): DWR Levee Log, 2005. USACE San Joaquin O&M Manual 3, December 1968, (HLM 0.66)].
FS Date: 9/10/2013

WS view: gate valve in CMP riser (bottom) and pipe & pump (top) on piling structure in the channel.

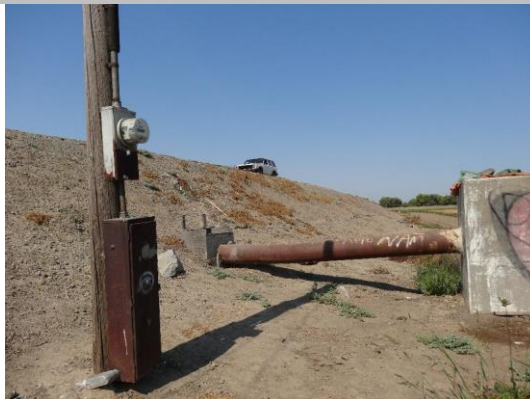
Photo 3 of 3 : UCIP_SP_2020_21464_36403.jpg

LS view: exposed pipe, service pole, and concrete distribution box on levee toe.

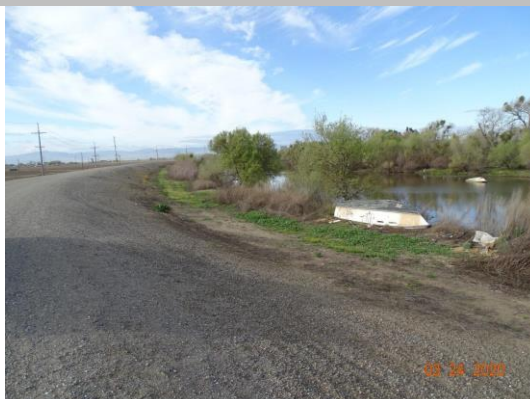
Photo 1 of 2 : SP_2020_RD2094_320_8_20200324_00016.jpg

LM Start	0.91	Rating **	M	Issue No.	8
LM End	0.91	Issue Type +	En	Location *	WS
Category	Earthen Levee			GPS Latitude/Longitude	
				Start	End
Item	Encroachments			37.764169 °	37.764169 °
				-121.293562 °	-121.293562 °
DWR ID	DWR_RD2094_01_s_2017_8				
Comment Code					
AV : Abandoned vehicles					
Inspector Comment					
There is an abandoned boat on the waterside bank.

View of abandoned boat on waterside bank. Spring 2020

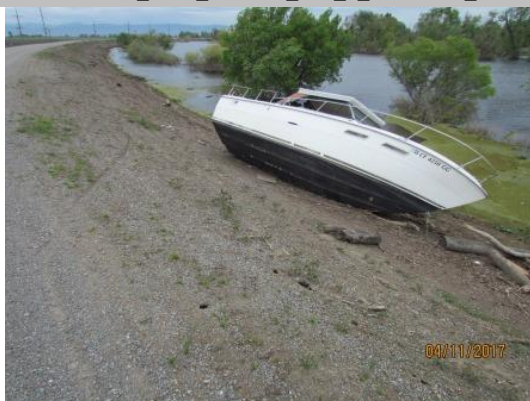
Photo 2 of 2 : SP_2020_RD2094_320_8_20200228_00003.jpg

View of the boat on the levee slope. Spring 2017

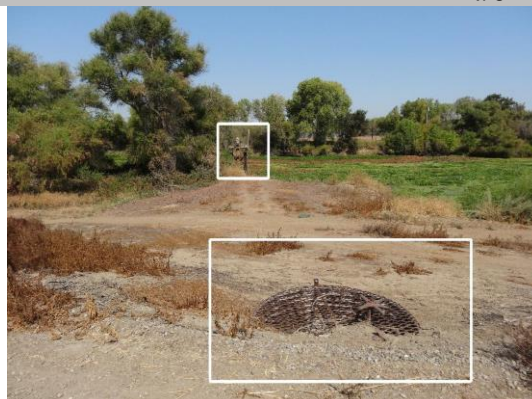
Photo 1 of 3 : UCIP_SP_2020_21544_36524.jpg

Comment Code						
Inspector Comment						
DS_ID:23087 FS_ID:21544 EP_NO: N/A Repair Type: Non-Urgent Crossing Status: Found UCIP Comments: - working as drainage system during field visit. Pump was not running.- electric conduit on WS- open pipe end in CMP riser. CMP needs cleaning. FIELD_STRUCT_DESC: 20-inch concrete encased steel irrigation discharge pipe through the levee, 10 feet below the crown. Two concrete cutoff walls. Pump mounted on a pile structure in the stream. Slide gate in a 54-inch corrugated metal pipe (CMP) riser on the waterside (WS) shoulder. Concrete distribution box and service pole at the landside (LS) toe. [Additional Reference(s): DWR Levee Log, 2005. USACE San Joaquin O&M Manual 3, December 1968, (HLM 1.27)]. FS Date: 9/10/2013

WS view: overview of pump (top) and CMP riser (bottom)

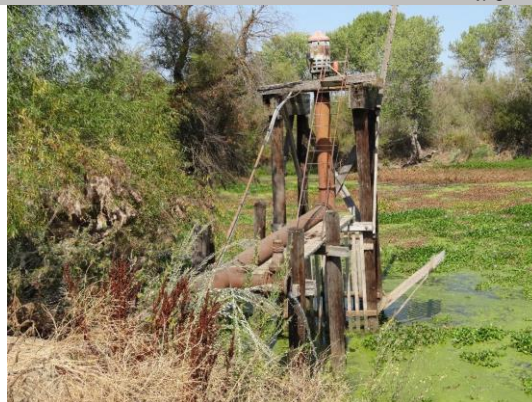
Photo 2 of 3 : UCIP_SP_2020_21544_36523.jpg

WS view: pipe and pump on piling structure in the channel. Walkway in poor condition.

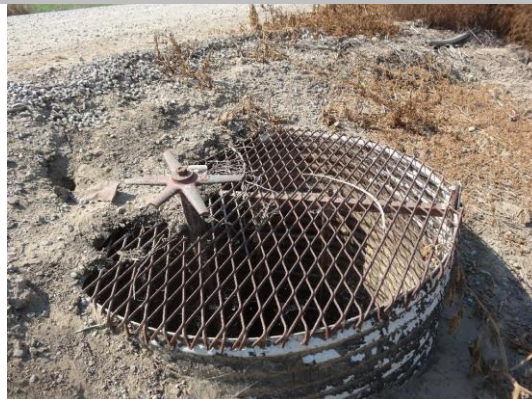
Photo 3 of 3 : UCIP_SP_2020_21544_36522.jpg

WS view: damaged gate valve handle in CMP riser on levee shoulder.

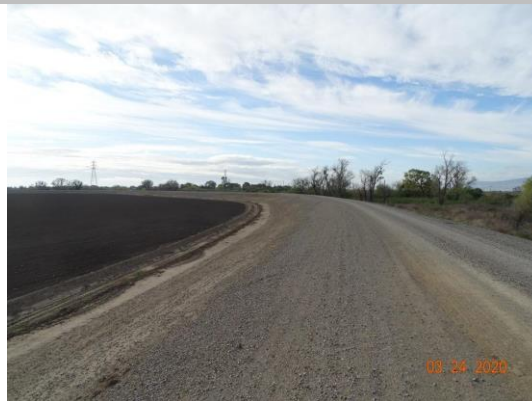
Photo 1 of 1 : SP_2020_RD2094_320_6_20200324_00017.jpg

Typical view of well maintained vegetation on landside slope. Spring 2020

LM Start	1.79	Rating **	A	Issue No.	6
LM End	1.79	Issue Type +	Ma	Location *	LS
Category	Earthen Levee			GPS Latitude/Longitude	
				Start	End
Item	Vegetation			37.754510 °	37.754510 °
				-121.302868 °	-121.302868 °
DWR ID	DWR_RD2094_01_s_2020_6				
Comment Code					
V1 : Control annual grass and weeds on the levee slopes and easements.					
Inspector Comment

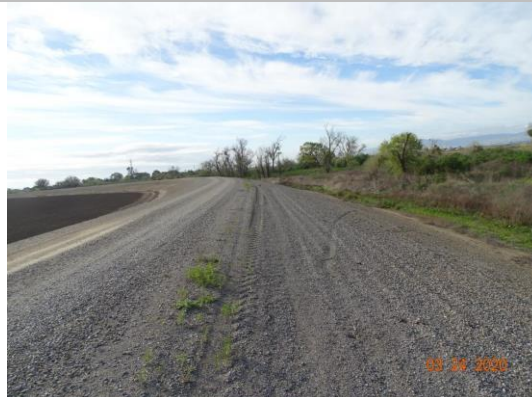
Photo 1 of 1 : SP_2020_RD2094_320_7_20200324_00018.jpg

Typical view of well maintained vegetation on waterside slope. Spring 2020

LM Start	1.79	Rating **	A	Issue No.	7
LM End	1.79	Issue Type +	Ma	Location *	WS
Category	Earthen Levee			GPS Latitude/Longitude	
				Start	End
Item	Vegetation			37.754510 °	37.754510 °
				-121.302868 °	-121.302868 °
DWR ID	DWR_RD2094_01_s_2020_7				
Comment Code					
V1 : Control annual grass and weeds on the levee slopes and easements.					
Inspector Comment

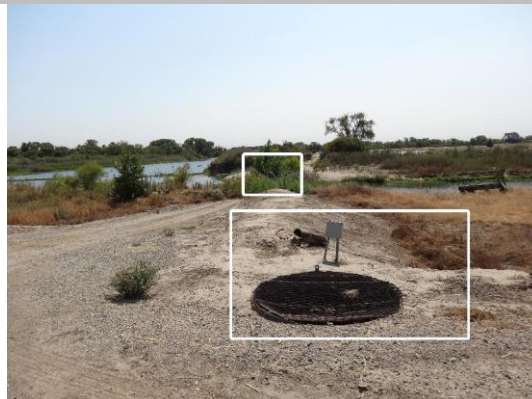
Photo 1 of 3 : UCIP_SP_2020_41726_36502.jpg

Comment Code						
Inspector Comment						
DS_ID:23088						
FS_ID:41726						
EP_NO: N/A						
Repair Type: Non-Urgent						
Crossing Status: Found						
UCIP Comments: - dense vegetation on WS.- working during field survey.- slide gate not found on WS.						
FIELD_STRUCT_DESC: 20-inch concrete encased steel irrigation discharge pipe through the levee, 6 feet below the crown. Two concrete cutoff walls. Slant pump mounted on a frame structure on the stream bank. Slide gate in a 54-inch corrugated metal pipe (CMP) riser on the waterside (WS) shoulder. Concrete distribution box and service pole at the landside (LS) toe. [Additional Reference(s): DWR Levee Log, 2005. USACE San Joaquin O&M Manual 3, December 1968, (HLM 2.30)].						
FS Date: 9/10/2013

WS view: slant pump (top) on stream bank and CMP riser on levee shoulder.

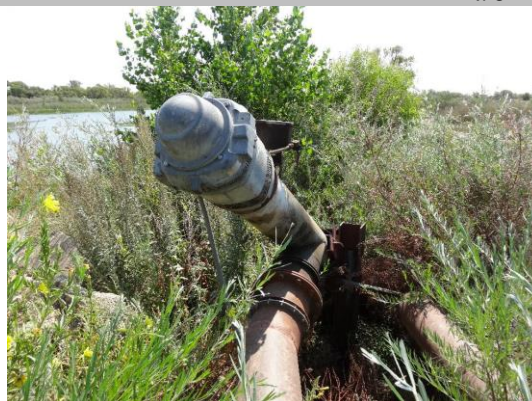
Photo 2 of 3 : UCIP_SP_2020_41726_36501.jpg

WS view: slant pump on stream bank and dense vegetation on stream bank.

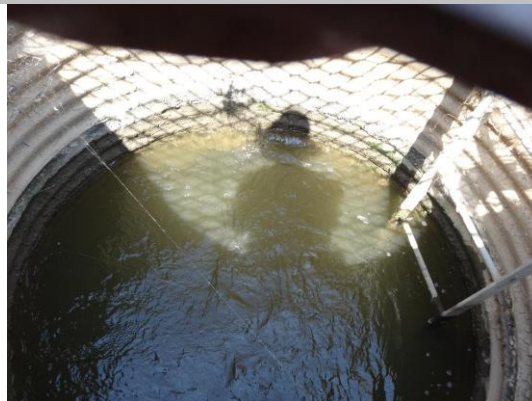
Photo 3 of 3 : UCIP_SP_2020_41726_36500.jpg

WS view: inside view of CMP riser on levee shoulder. No slide gate found.

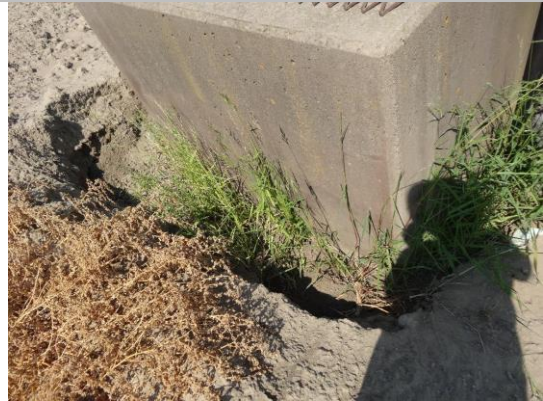
Photo 3 of 3 : UCIP_SP_2020_21545_36527.jpg

LS view: erosion around a concrete standpipe on the landside toe.

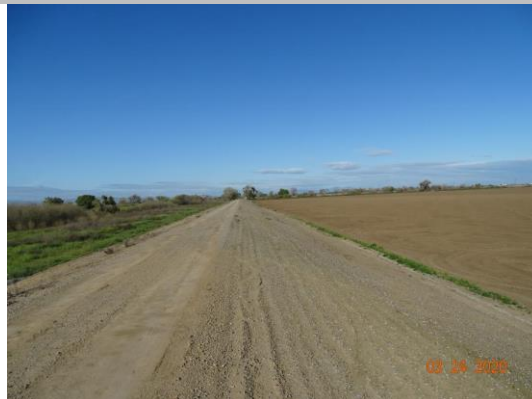
Photo 1 of 1 : SP_2020_RD2094_321_1_20200324_00002.jpg

Typical view of well maintained vegetation on landside slope. Spring 2020

LM Start	0.20	Rating **	A	Issue No.	1
LM End	0.20	Issue Type +	Ma	Location *	LS
Category	Earthen Levee			GPS Latitude/Longitude	
				Start	End
Item	Vegetation			37.760619 °	37.760619 °
				-121.302748 °	-121.302748 °
DWR ID	DWR_RD2094_02_s_2020_1				
Comment Code					
V1 : Control annual grass and weeds on the levee slopes and easements.					
Inspector Comment
